**U.S. EPA REGION VIII
TECHNICAL ENFORCEMENT PROGRAM
RCRA CORRECTIVE ACTION ASSESSMENT REPORT**

Facility: Asarco East Helena Plant
100 Smelter Road
East Helena, MT

Inspection Type: Corrective Action Assessment Inspection

Date: April 30, 2008
Time In: 10:15 a.m.
Time Out: 1:50 p.m.

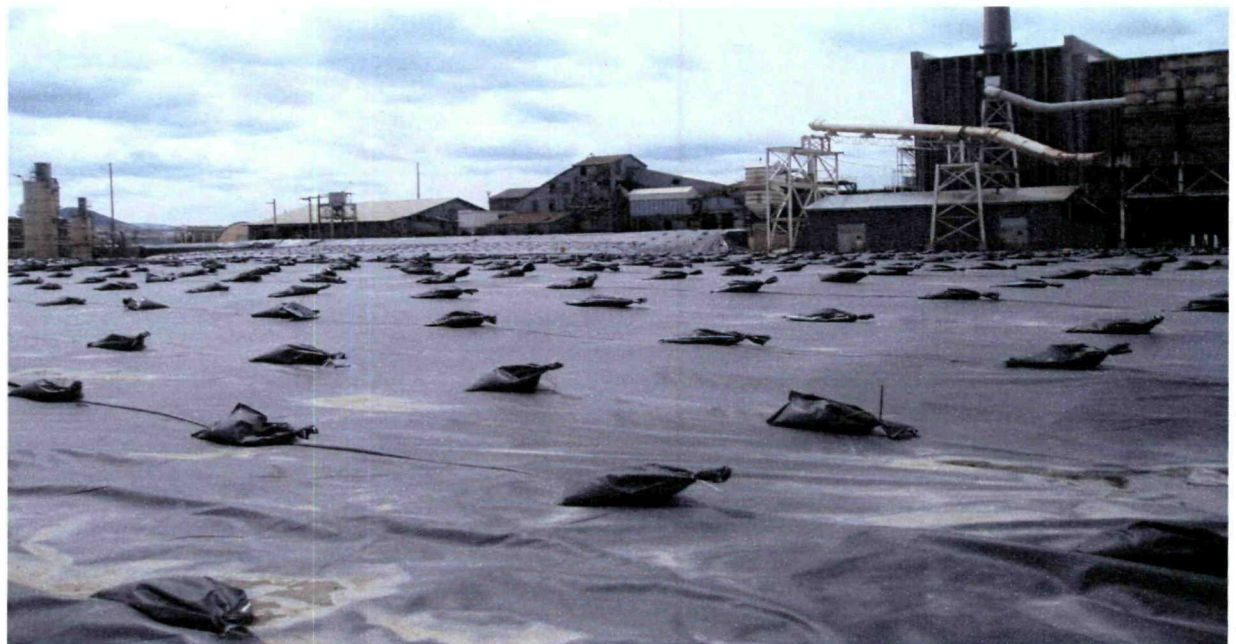
Photo 47; Facility: Asarco East
Helena Smelter; Subject: Cell
Construction; Date: April 30, 2008;
Photographer: Linda Jacobson

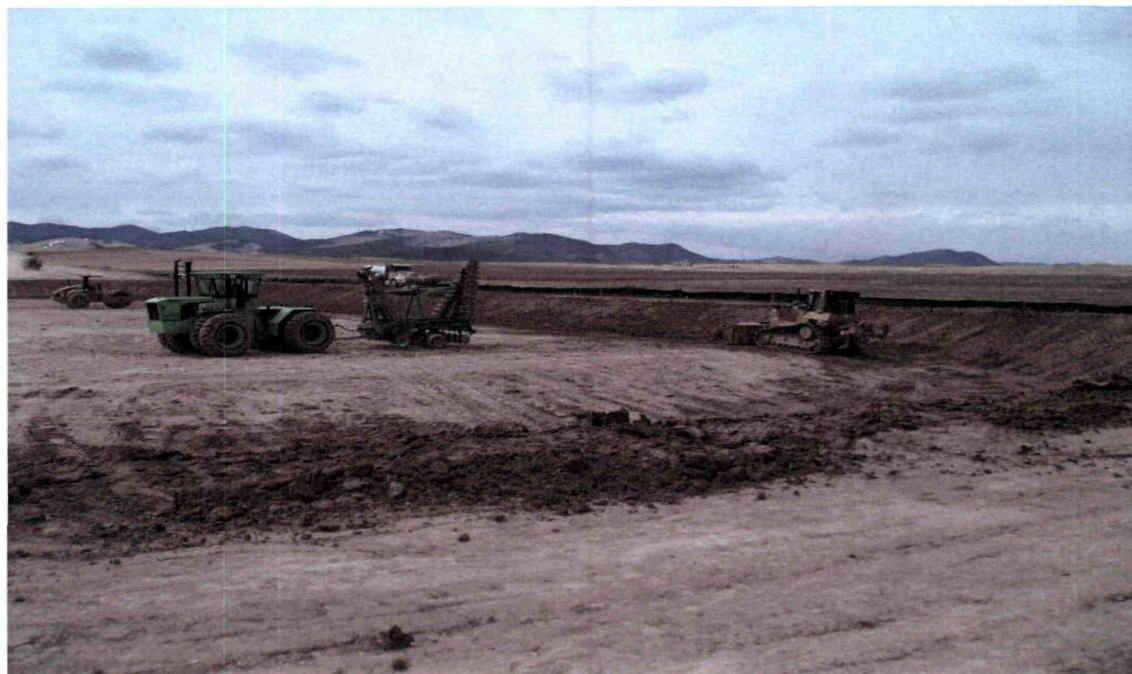
Photo 48; Facility: Asarco East
Helena Smelter; Subject: CAMU Cell 2
Date: April 30, 2008;
Photographer: Linda Jacobson

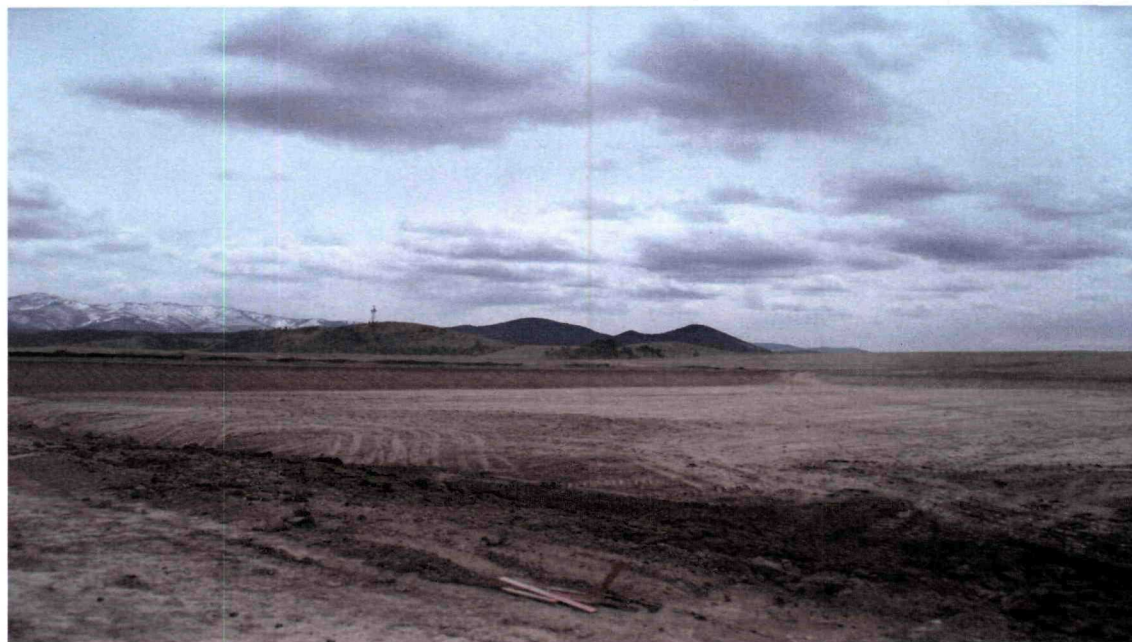
Photo 49; Facility: Asarco East
Helena Smelter;
Subject: CAMU Cell 2 Construction
Date: April 30, 2008;
Photographer: Linda Jacobson

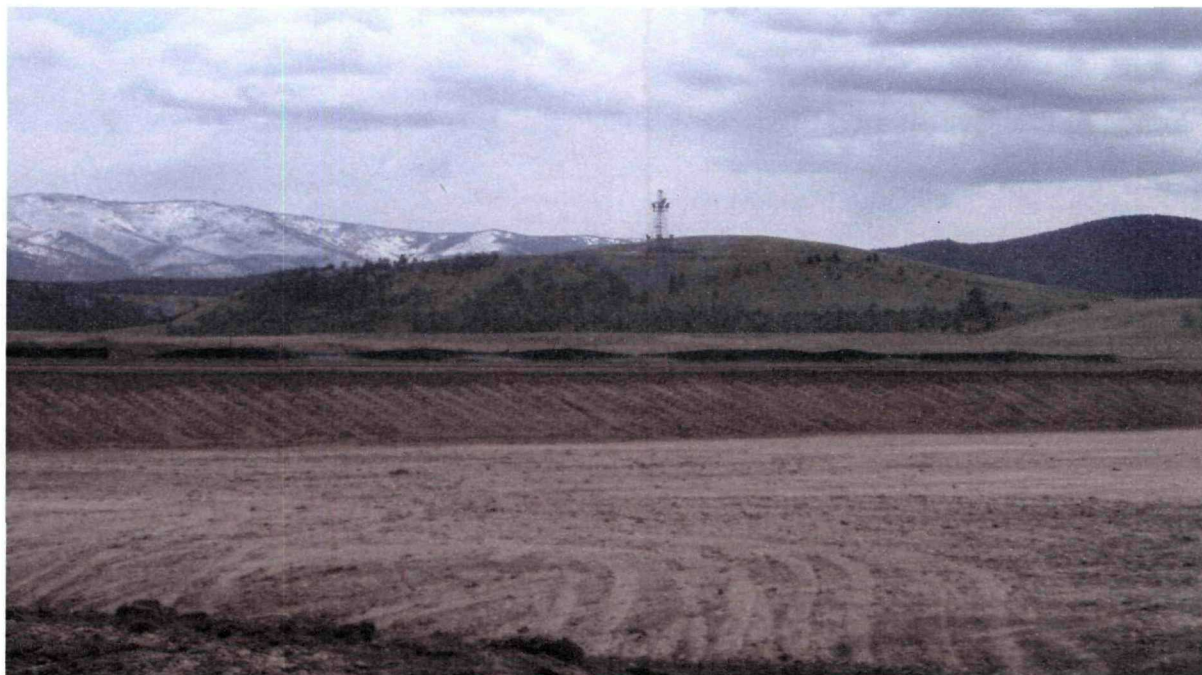
Photo 50; Facility: Asarco East
Helena Smelter;
Subject: CAMU Cell 2 Construction
Date: April 30, 2008;
Photographer: Linda Jacobson

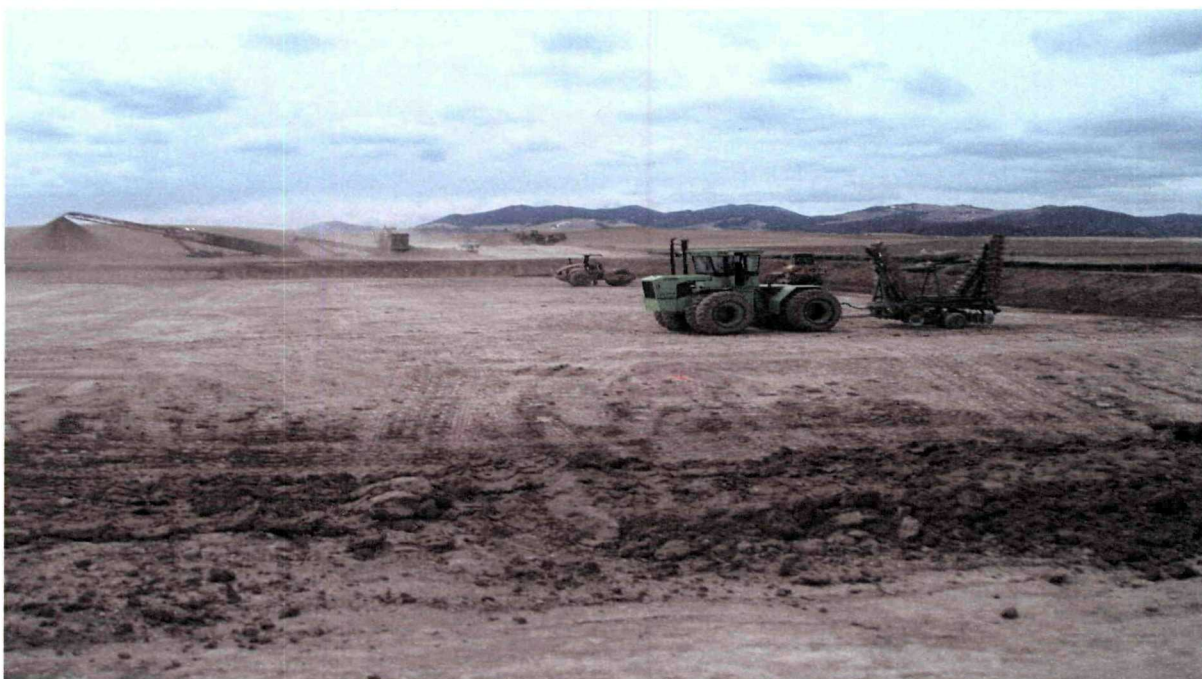
Photo 51; Facility: Asarco East
Helena Facility;
Subject: CAMU Cell Construction;
Date: April 30, 2008;
Photographer: Linda Jacobson

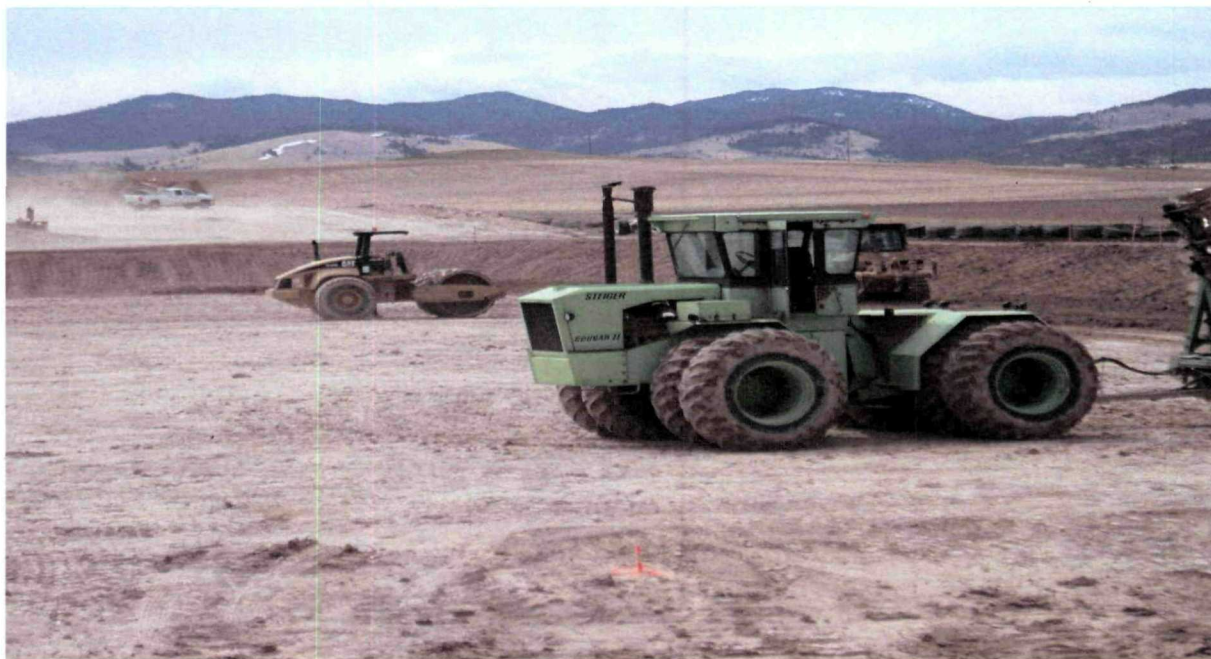
Photo 52; Facility: Asarco East
Helena Smelter;
Subject: Screening of Soil for
Cell Construction;
Date: April 30, 2008;
Photographer: Linda Jacobson

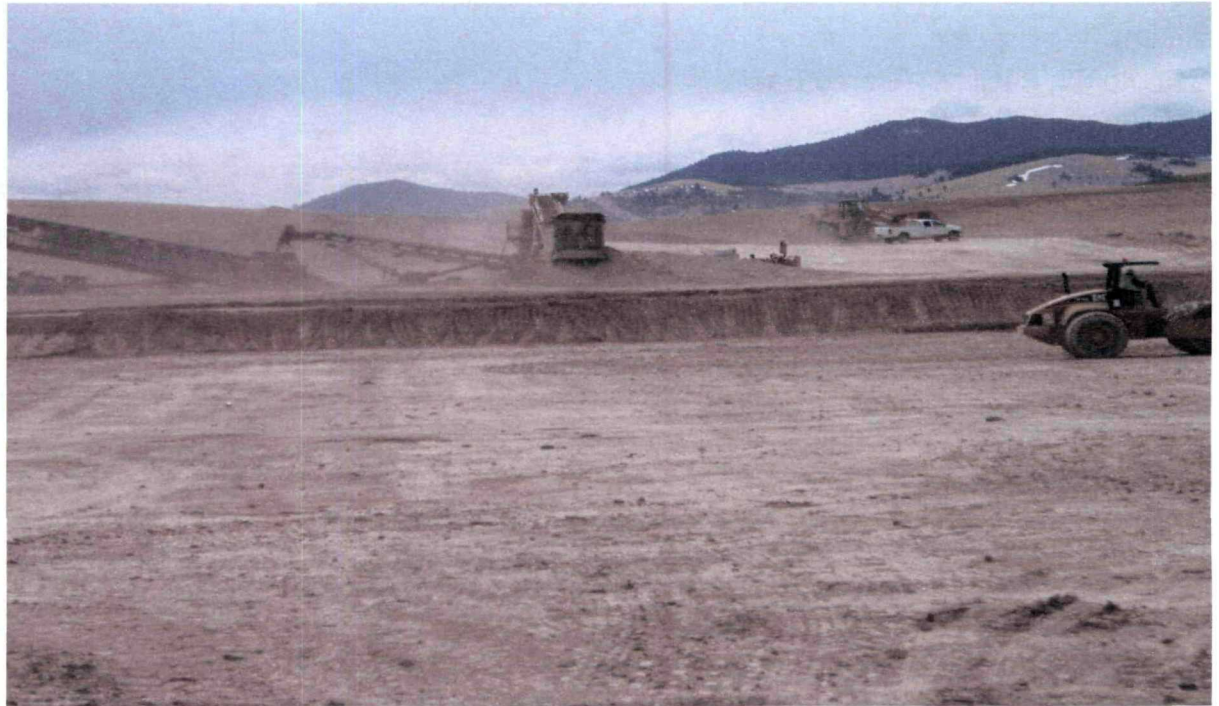
Photo 53; Facility: Asarco East
Helena Smelter; Subject:
Screening of Soils for Inclusion in
CAMU Cell 2 Construction
Date: April 30, 2008;
Photographer: Linda Jacobson

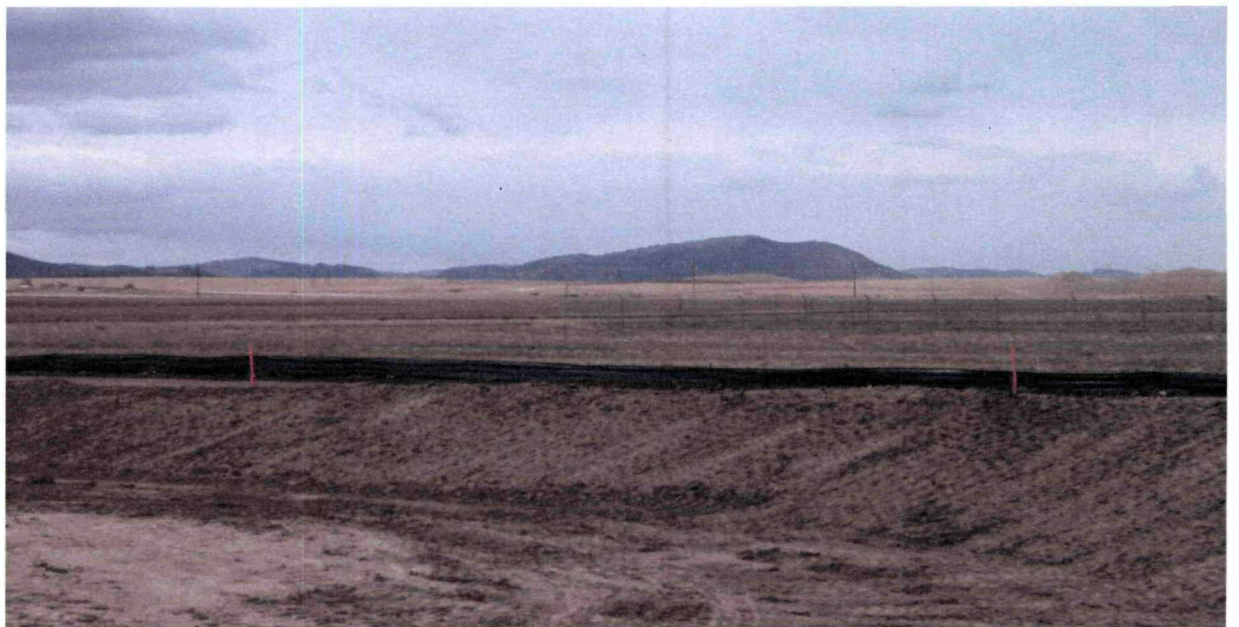
Photo 54; Facility: Asarco East
Helena Smelter; Subject: Side of
CAMU Cell 2 Clay Liner
Date: April 30, 2008;
Photographer: Linda Jacobson

They then proceeded to the site of the new CAMU cell, where they were met by Mark Rhodes, Hydrometrics Project Manager, Jason Rolfe, Womack and Associates, Greg Lorensen, Hydrometrics, and Shaun O'Connor, Cleveland Wrecking System Site Manager. Mr. Rhodes explained that the last lift of clay on the cell floor was being disked. The cell side slopes were to grade. The synthetic liner work will proceed from east to west beginning at the south wall. Screening of clay was continuing from the new borrow area referred to as the south excavation area.

Ms. Jacobson and Mr. Miller asked about the liner hydraulic conductivity results. Mr. Rhodes stated that 2 samples were about 1×10^{-7} and one was in the mid 1×10^{-6} range. Mr. Rolfe stated that his results were 1.1×10^{-6} and 1.2×10^{-6} .

Mr. Rhodes stated that they will disk and moisture condition the last six inches and recompact the clay liner. A haul road will be built in a loop on the north side of the cell.

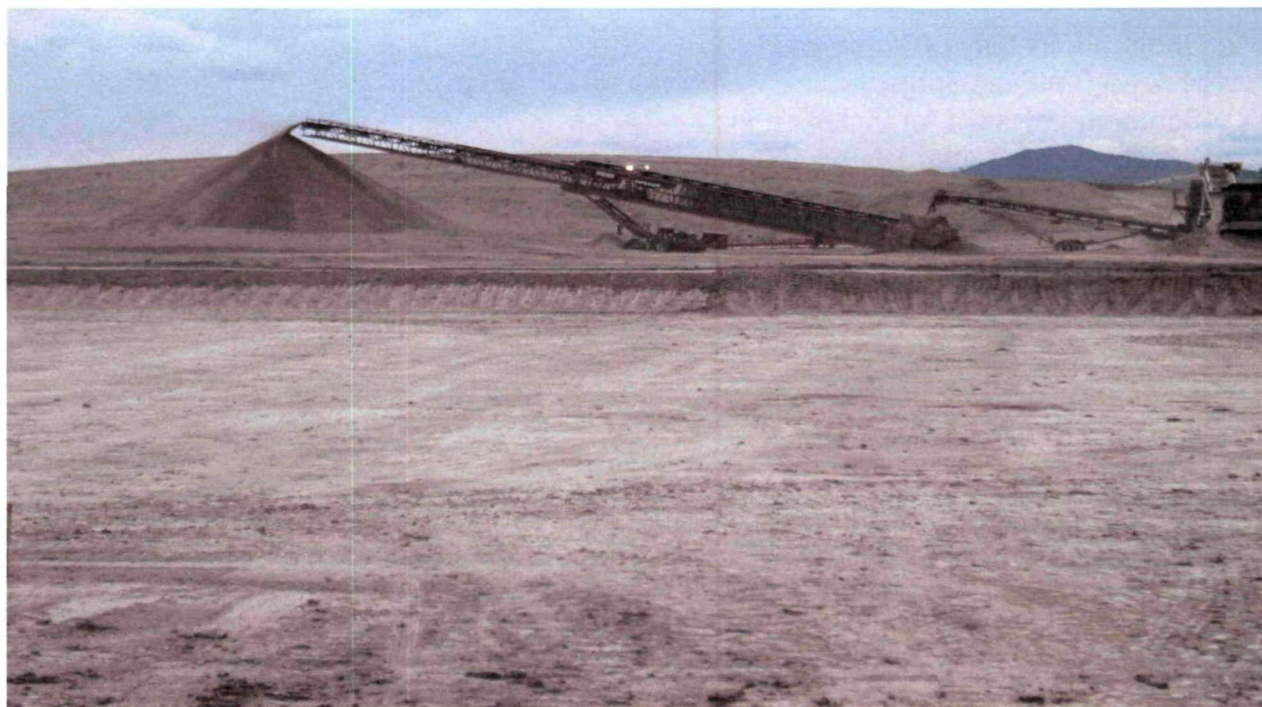
Photo 55; Facility: Asarco East
Helena Smelter; Subject:
Screened Pile of Soil
Date: April 30, 2008;
Photographer: Linda Jacobson
